Manhole Inspection Summary

Manhole # S51C__005MH

Location Address: **132 n decker st**

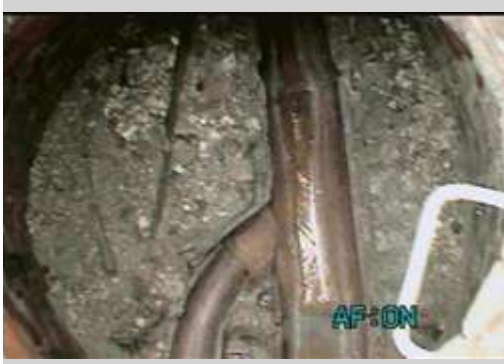
Defect 1

Condition: ☐ Sound ☐ Cracked ☐ Root Intrusion ☐ Deteriorated ☐ Leaks ☒ **Debris**

bench debris

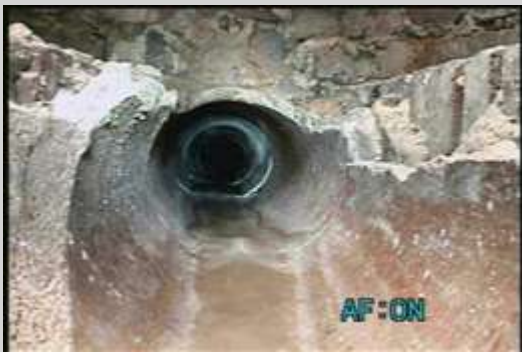
12 O'Clock Outflow

8 in. Circular Gravity Sewer
Pipe Out @ 12 O'Clock

Invert Depth: 4.80 (ft.) Flow Characteristics: **Slow**

Deposits: ☒ None ☐ Mud ☐ Sludge ☐ Debris ☐ Grease

Infiltration: **None** Pipe Seal Cond: **Unknown**

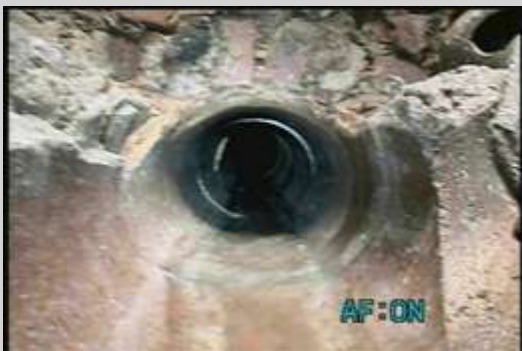
6 O'Clock Inflow

8 in. Circular Gravity Sewer
Pipe In @ 6 O'Clock

Invert Depth: 4.60 (ft.) Flow Characteristics: **Slow**

Deposits: ☒ None ☐ Mud ☐ Sludge ☐ Debris ☐ Grease

Infiltration: **None** Pipe Seal Cond: **Unknown**

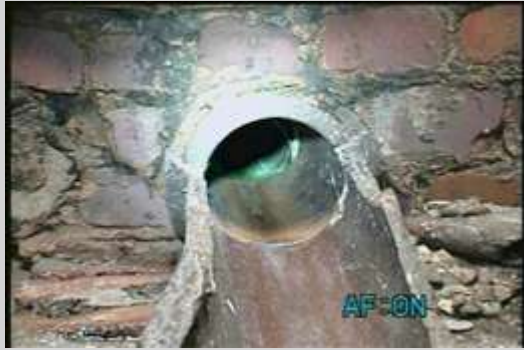
7 O'Clock Inflow

6 in. Circular Gravity Sewer
Pipe In @ 7 O'Clock

Invert Depth: **4.60** (ft.) Flow Characteristics: **None**

Deposits: ☒ None ☐ Mud ☐ Sludge ☐ Debris ☐ Grease

Infiltration: **None**

Connects To: **House connection / Service line**
